SINUMERIK 808D, SINUMERIK 808D ADVANCED Diagnostics Manual

Diagnostics Manual

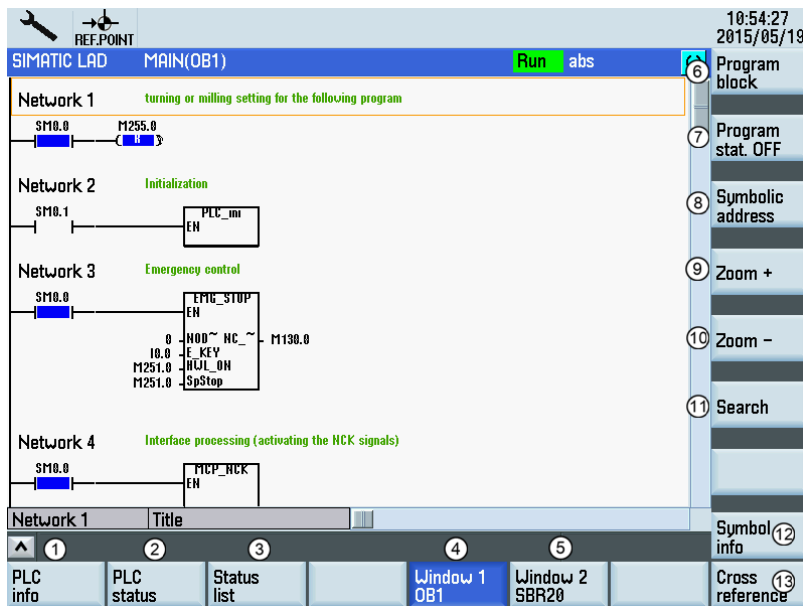
You can open the project stored in the permanent memory through the following operations:

- ① Displays PLC properties
- ② Monitors and changes the values of the operands during program execution
- ③ Displays and modifies PLC signals
- ④ Displays any logical and graphical information of a program block
- ⑤ Displays any logical and graphical information of a program block in another window
- ⑥ Displays the list of cross references
- ⑦ Displays the logic and graphic information of the selected program block
- ⑧ Activates or deactivates the program status display
- ⑨ Switches between the absolute and symbolic representation of the operands. The softkey labelling changes accordingly.
- ⑩ Zooms in the application area
- ⑪ Zooms out the application area
- ⑫ Searches for operands
- ⑬ Displays all symbolic identifiers used in the selected network

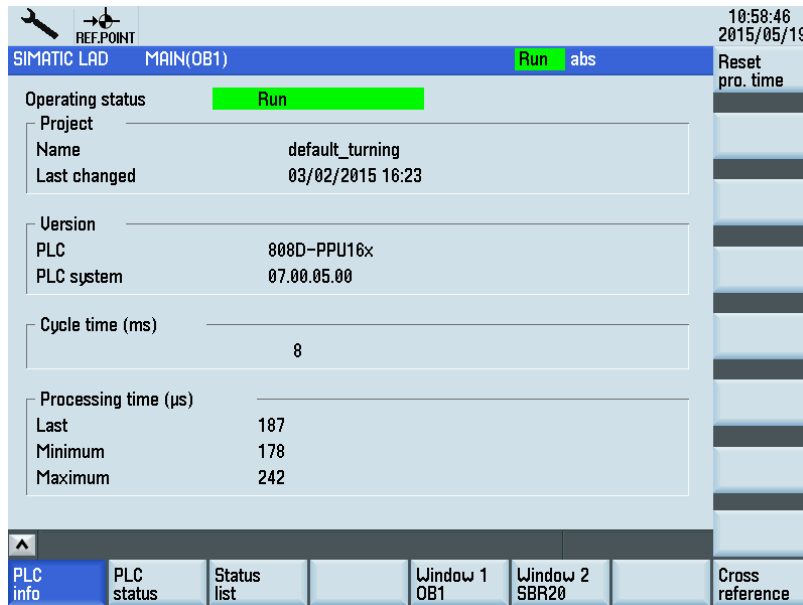
Press this softkey on the PLC program start screen to view the following PLC properties:

- Operating status
- Project name and change info
- PLC version and system info
- Cycle time
- Processing time of the PLC user program

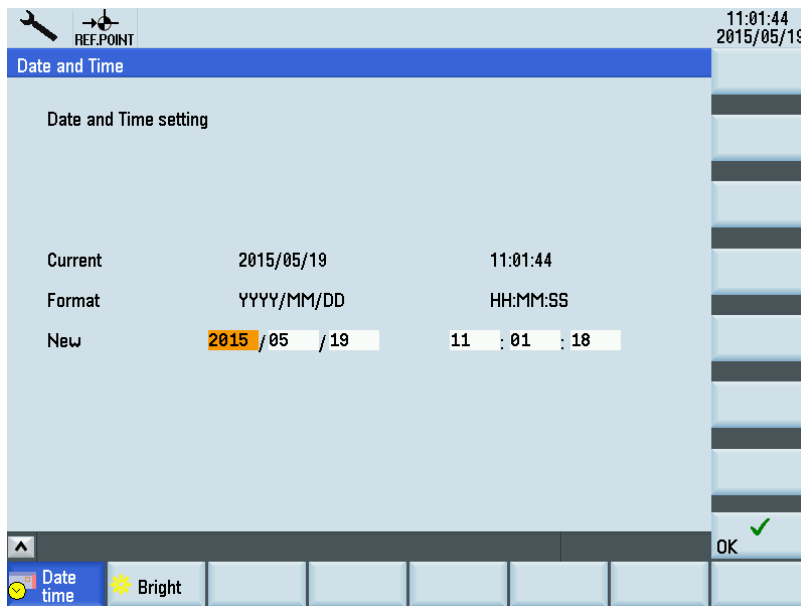
3.5.1 Setting the date and time

At delivery, the system date and time remain at the factory settings, and thus you must manually modify the date and time in the window as follows.

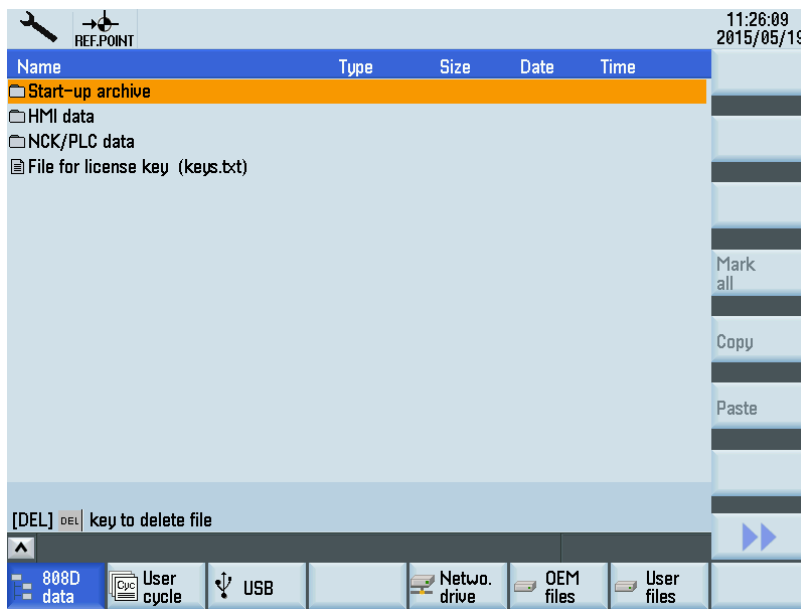
By pressing this softkey in the system data operating area, you can enter the window as follows:

Three folders and one file are available in this window. Note that the last three entries are visible with the manufacturer password only. You can import/export the subfolders or single files for backup or other customized purposes.

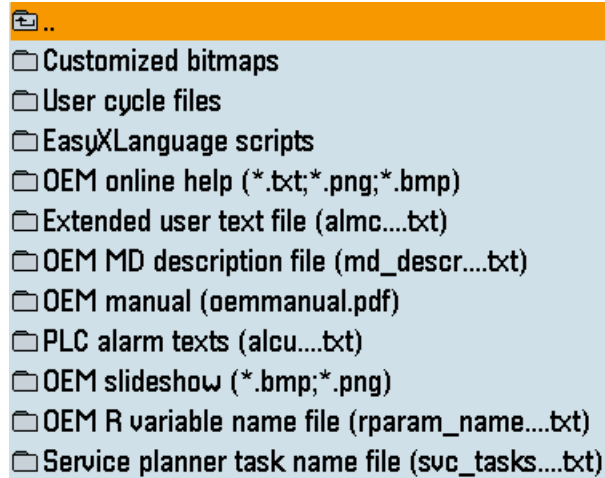
Select this folder and press this key to enter. There are 11 subfolders available in this folder as follows:

You can import/export the subfolders or single files in this window for backup or other customized purposes.

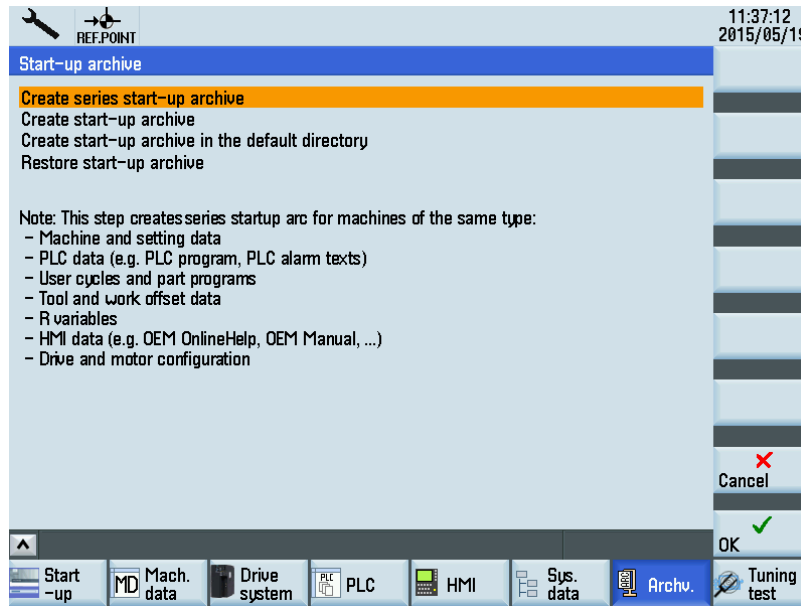
Pressing this softkey allows you to create or restore a data archive in the following window.

Note that some entries in this window are visible with the manufacturer password only. For more information, see section "External data backup in a data archive (Page 567)".

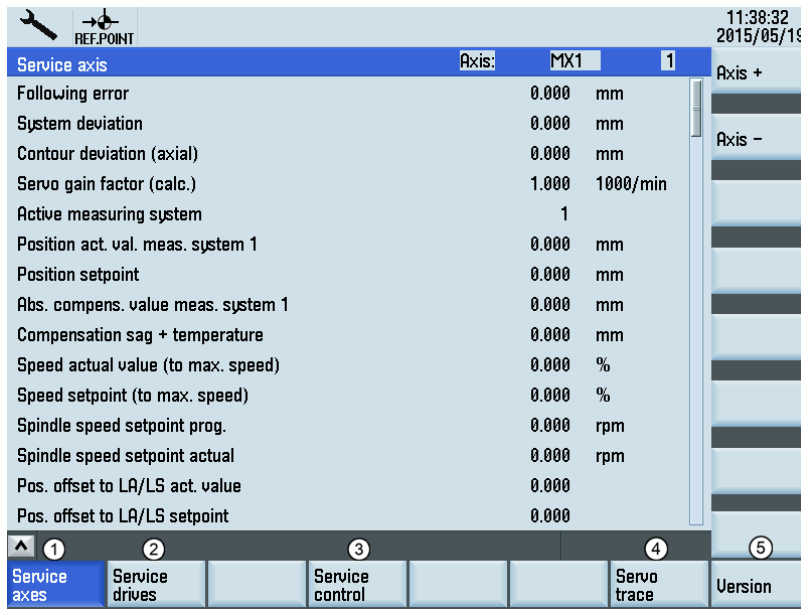
3.8 Viewing the service info

- ① Displays information of the axes.
- ② Displays information of the drives. Note that this softkey is available on the PPU161.3/ PPU160.2 only.
- ③ Displays the action log for service events, provides the possibility of sending service messages, and configures the Ethernet connection.
- ④ Compares the defined machine data with the actual data, and adjust the parameters if necessary. For more information, see Section "Servo trace (Page 37)".
- ⑤ Displays the version numbers and the date of creation of the individual CNC components. For more information, see Section "Version/HMI details (Page 40)".

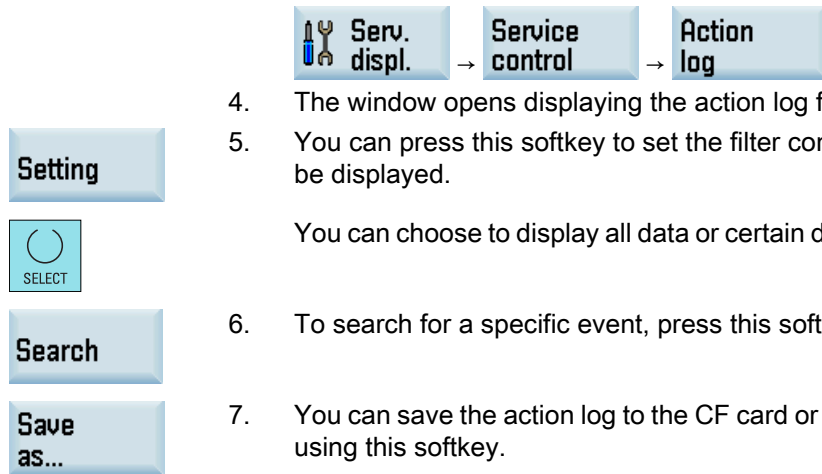
1. Select the system data operating area.
2. Press this key to view the extended softkeys.
3. Open the action log window through the following softkey operations:

4. The window opens displaying the action log for the service events.
 5. You can press this softkey to set the filter conditions for the data to be displayed.
You can choose to display all data or certain data groups with this key.
 6. To search for a specific event, press this softkey.
 7. You can save the action log to the CF card or a USB stick (if inserted) using this softkey.

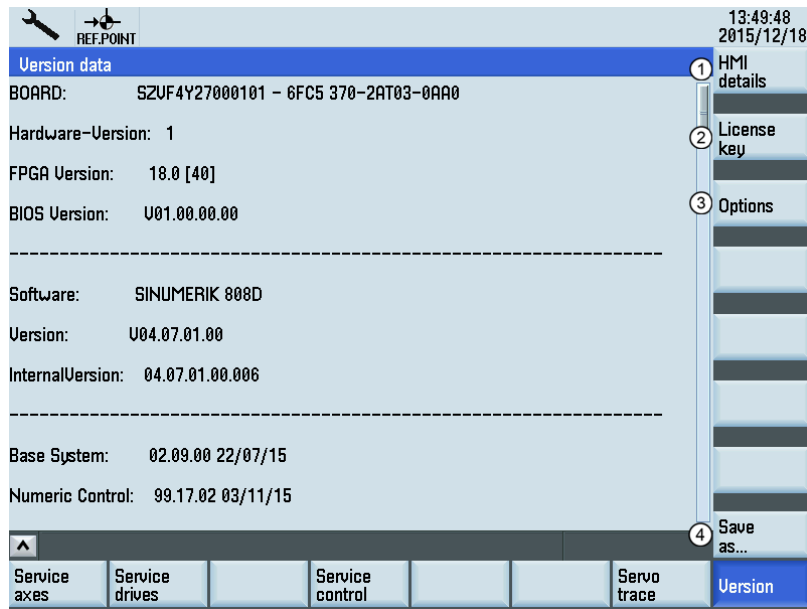
This window displays the version numbers and the date of creation of the individual CNC components.

- ① Displays the operator programs with the version numbers
- ② Opens the window for entering the license key. This softkey is accessible with the manufacturer or higher-level password only.
- ③ Activates the licensed optional functions. This softkey is accessible with the manufacturer or higher-level password only.
- ④ Saves the version data as a file

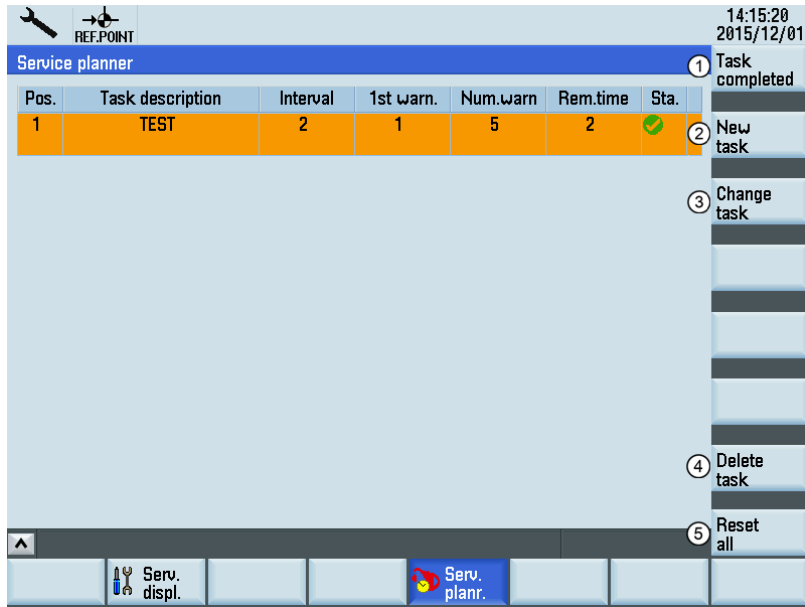
In the service planner window, you can monitor the status of the maintenance tasks and acknowledge the tasks completed.

① Acknowledges the selected task which has been completed

④ Deletes the selected task

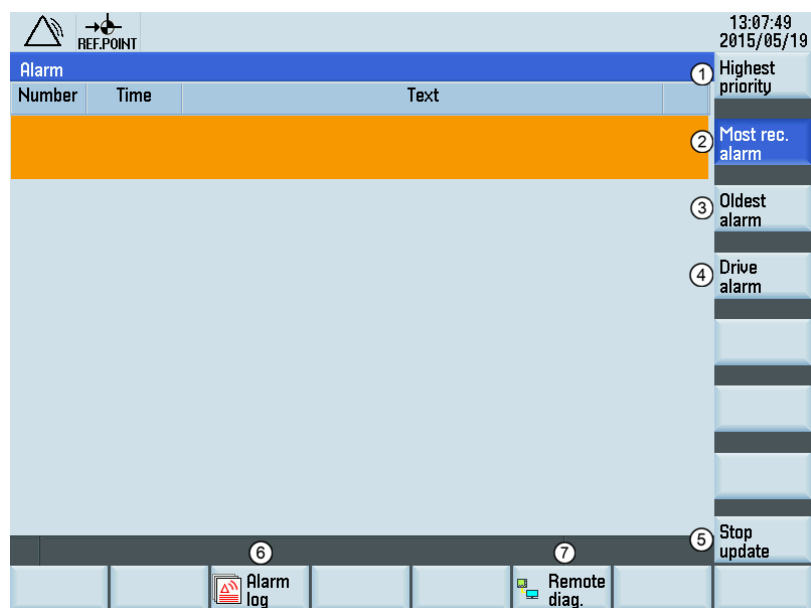
Pressing this key on the PPU allows you to enter the alarm operating area. You can check the NC and drive alarms using the softkeys. PLC alarms are not sorted.

- ① Displays all alarms sorted by their priorities. The highest priority alarm is at the beginning of the list.
- ② Displays the alarms sorted by the time of their occurrence. The most recent alarm stands at the beginning of the list.
- ③ Displays the alarms sorted by the time of their occurrence. The oldest alarm stands at the beginning of the list.
- ④ Displays the alarms on the drives. Note that this softkey is available on the PPU161.3 and PPU160.2 only.
- ⑤ Stops/starts updating of pending alarms
- ⑥ Views and manages the alarm log
- ⑦ Configures the access right for the remote control through the Ethernet connection. For more information about the softkey function, see the SINUMERIK 808D/SINUMERIK 808D ADVANCED Commissioning Manual.
