Operating instructions

Servo drive system SINAMICS S210

SINAMICS S210 SIMOTICS S-1FK2

Firmware V5.1

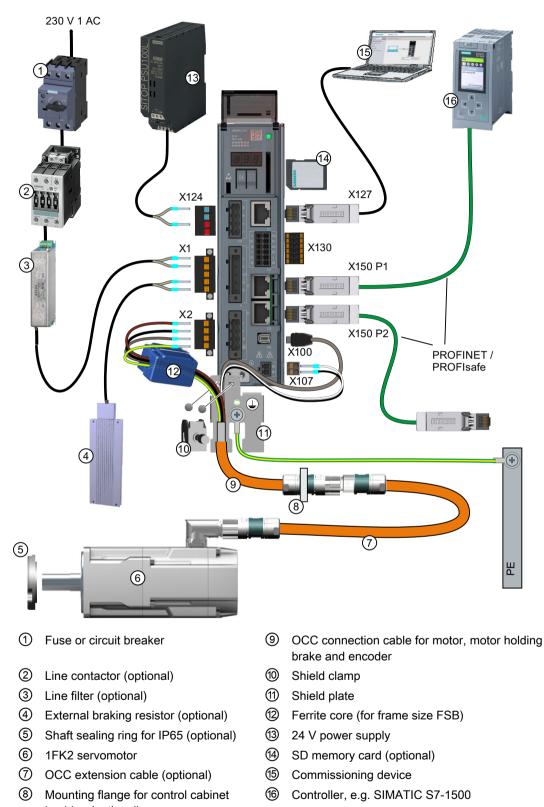
bushing (optional) Figure 2-2 System components and accessories 2.2 The scope of supply for the system components

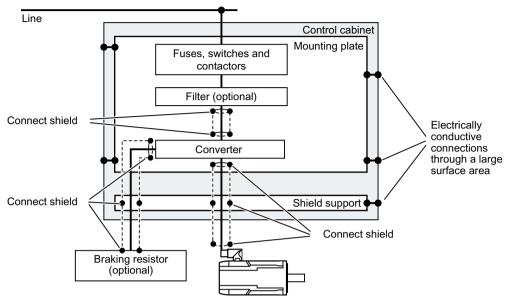
- Ground any unused conductors of signal and data cables at both ends.
- Signal and data cables must only enter the cabinet from one side, e.g. from below.

- Use shielded cables for the following connections:
 - Cable between the converter and line filter
 - Cable between the converter and motor
 - Cable between the converter and external braking resistor

Figure 3-1 Routing converter cables inside and outside a control cabinet

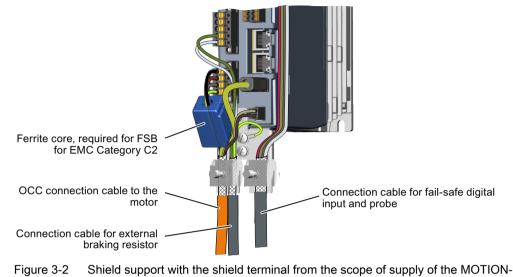
- Use cables with finely-stranded, braided shields.
- Connect the shield at both ends of the cable.

- CONNECT OCC cable.
- Connect the shield to the shield support.
- Do not interrupt the shield.

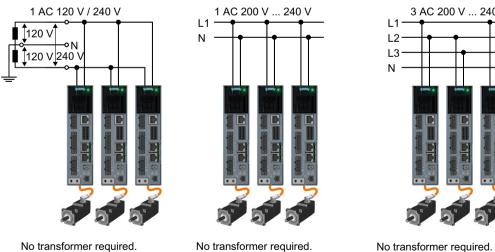
You have the following options to supply the converter with an input voltage of 230 V.

Figure 3-4 Connection options

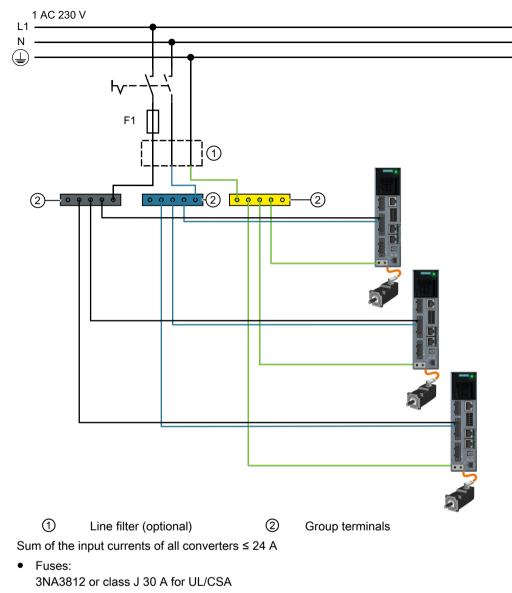
- Cables for the line connection up to the terminal box 4 mm², dimensioned for $I_{\rm rms} \ge 32 \text{ A}_{\rm rms}$ at 50 °C
- Cables for the connection from the terminal box to the converter 2.5 mm², dimensioned for $I_{\rm rms} \ge$ 18.5 A at 50 °C

Figure 3-5 Connection example for 230 V 1 AC

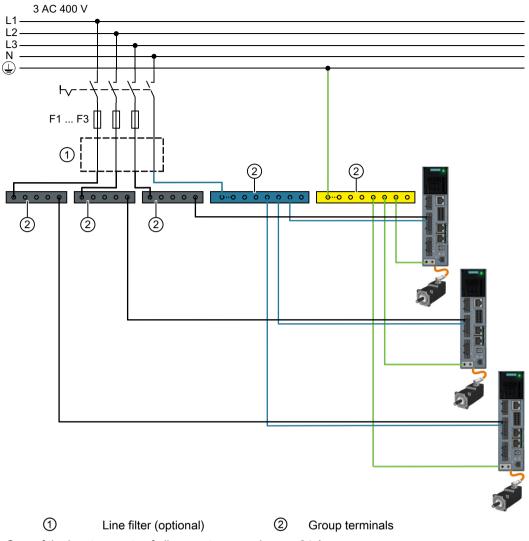
Sum of the input currents of all converters per phase ≤ 24 A

- Fuses, F1 ... F3 3NA3812 or class J 30 A for UL/CSA
- Cables for the connection from the terminal box to the converter 4 mm², dimensioned for $I_{ms} \ge 32$ A at 50 °C
- Cables for the line connection up to the terminal box 2.5 mm², dimensioned for $l_{\rm rms} \ge 18.5$ A at 50 °C

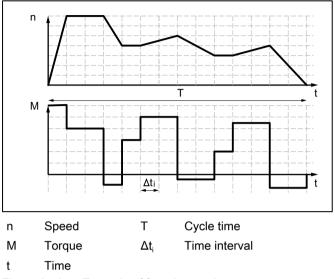
A free duty cycle defines the curve of the motor speed and the torque over time.

Figure 3-10 Example of free duty cycle

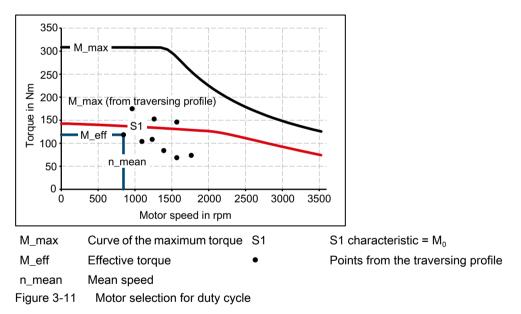
The effective torque M_{eff} must lie below the S1 characteristic.

The maximum torque M_{max} is produced during the acceleration operation. M_{max} must lie below the voltage limiting characteristic curve. In summary, the motor is configured as follows:

You have defined the characteristic motor values corresponding to the duty cycle.

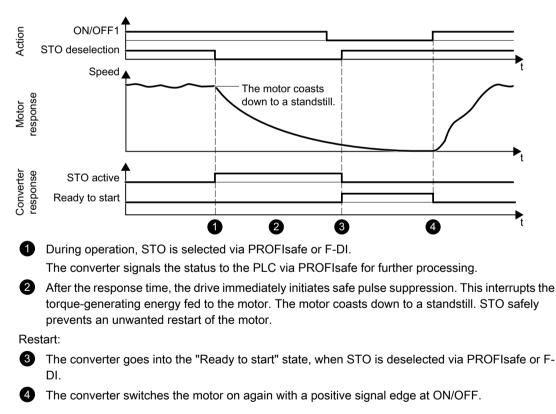
Sequence diagram

Selecting/deselecting "Safe Torque Off"

If "Safe Torque Off" is selected, the motor holding brake is closed (if connected and configured).

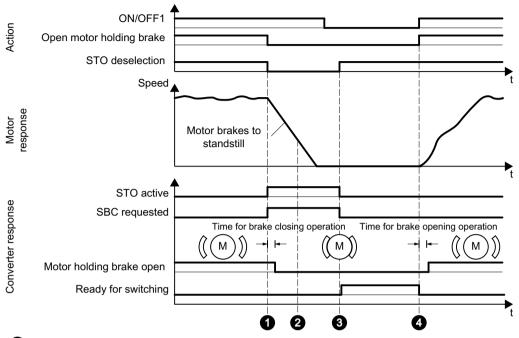
Sequence diagram

STO is selected during operation via the control bit of the selected PROFIsafe telegram or via the F-DI.

Safe Brake Control (SBC) is activated at the same time. Taking the brake closing time (r1217) into account, the command to close the motor holding brake closes the brake, thus supporting the shutdown process initiated by STO.

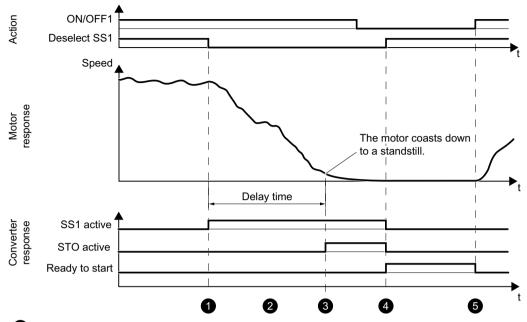
Flow diagram SS1 with OFF3 (SS1-t)

SS1 is selected during operation (selection via the control bit of the selected PROFIsafe telegram or via F-DI).

The converter signals the status "SS1 active" via the status bit of the PROFIsafe telegram to the PLC for further processing.

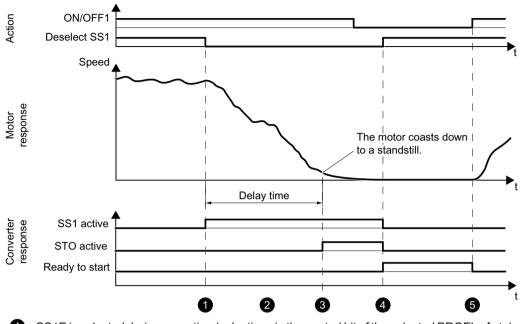
Flow diagram SS1 with external stop (SS1E)

SS1E is selected during operation (selection via the control bit of the selected PROFIsafe telegram or via F-DI).

When the safety function SS1E is used, the drive is shut down using the user program of a higher-level control system. Although the safe delay time is activated when SS1E is selected, OFF3 is not activated. The converter signals via PROFIsafe or the Safety Info Channel (SIC) of the supplementary telegram that SS1 was selected. Using an appropriate program, the control must then ramp down the drives involved within the delay time to the safe state. After the delay time has elapsed, the converter activates the STO function and safely interrupts the energy feed to the motor (independent of the actual speed).

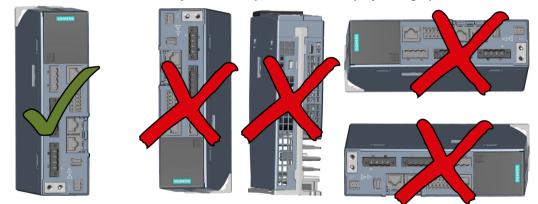
• Install the converter vertically with the flap for the LED display facing upwards.

Figure 5-2 Mounting position of the converter

- Maintain the minimum clearances to other components.
- Use the recommended hardware (screws M5) and comply with the specified torques.

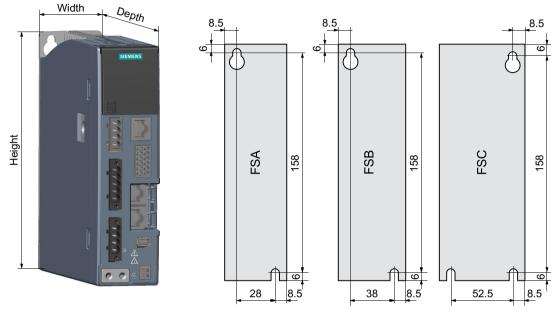
Leave a minimum 100 mm clearance to other devices at the top and bottom. A lateral clearance between multiple SINAMICS S210 converters is not mandatory. Observe a lateral clearance of at least 10 mm to other devices.

Figure 5-3 Dimension drawing and drilling dimensions

Frame size	Width	Height	Depth	Weight
FSA	45 mm	170 mm	170 mm	1.1 kg
FSB	55 mm	170 mm	170 mm	1.2 kg
FSC	70 mm	170 mm	195 mm	1.9 kg

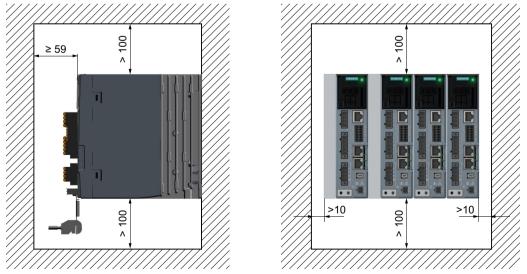
Figure 5-4 Distances to cabinet walls and other components

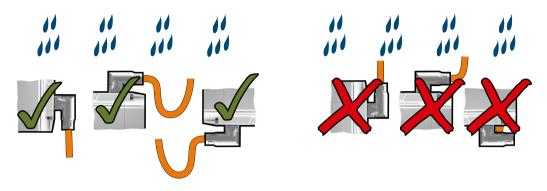
If you are operating the motor in environments in which moisture can arise follow the installation instructions below.

Figure 5-9 Permissible and impermissible cable routing when connecting in a damp environment

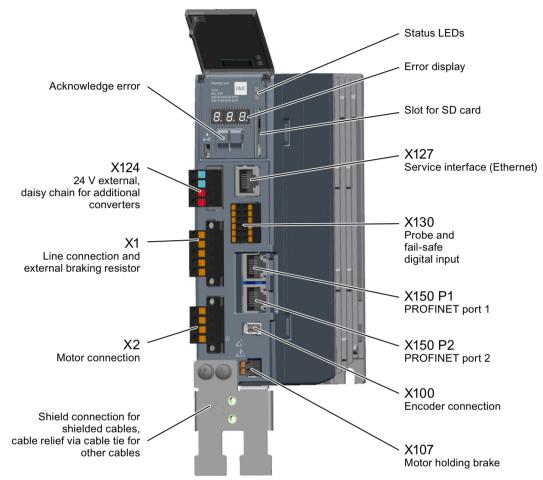
Figure 5-10 Overview of connections and operator controls on the converter

Type of connection	Connector	
Control voltage 24 VDC	X124	Included in the scope of sup- ply
Line connection and external braking resistor	X1	Included in the scope of supply
Motor power connections	X2	Included in the scope of sup- ply
Service interface	X127	RJ45
Digital inputs	X130	Included in the scope of sup- ply
Connection to the control system via PROFINET	X150 P1	RJ45
	X150 P2

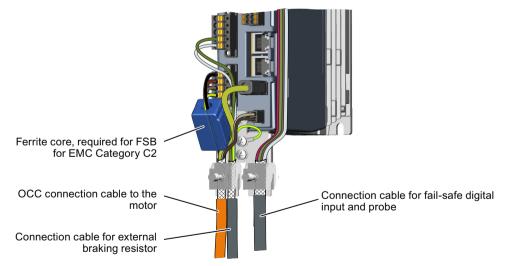
Use the shield support that comes with the converter to connect the shield. Siemens recommends connecting the shield - as shown in the figure - with the shield clamp that comes with the prefabricated OCC cable for the motor connection.

- Connect the shield at both ends of the cable.
- Use cables with finely-stranded, braided shields.
- Do not interrupt the shield.

Ferrite core with FSB

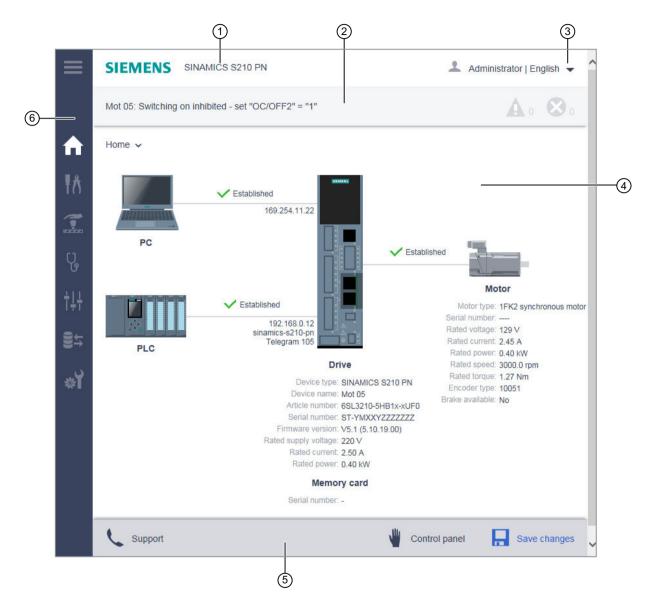
6.3 Structure of the Web browser

- ① Device designation
- ② Status bar (from left to right):

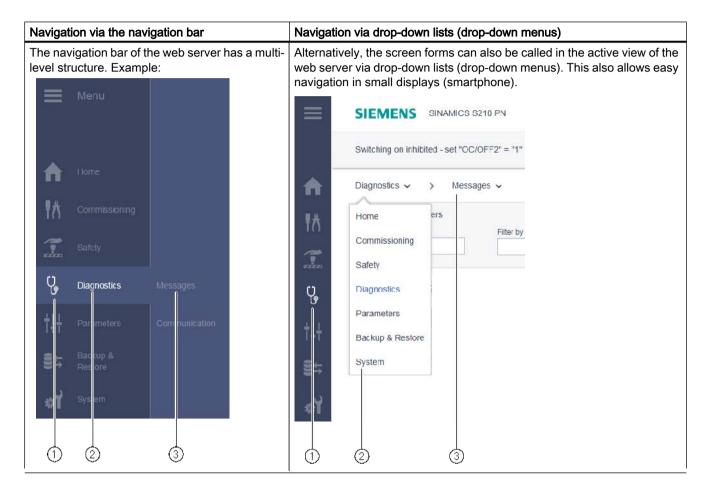
The web server provides the following options for navigating:

- ① Main menu as icon
- 2 Main menu in text format
- ③ Submenus of the active main menu

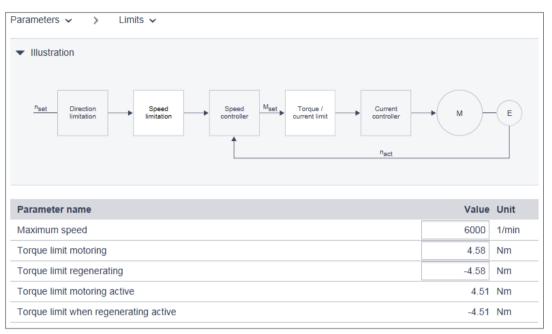
When required, you can configure limits for elements of your converter and adapt to the requirements of your mechanical system in the "Parameters - Limits" view.

Figure 6-11 Parameters - Limits

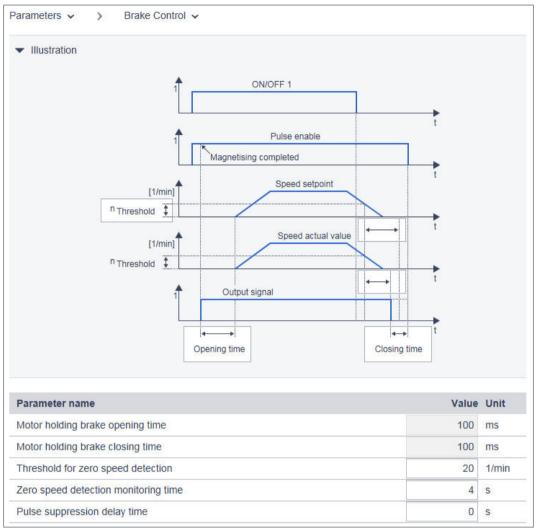
- 2. If required, adapt the brake control values in the "Value" column:
 - "Standstill detection speed threshold"
 - "Standstill detection monitoring time"
 - "Pulse cancellation delay time"
- 3. Click 🔚 to save the data permanently.

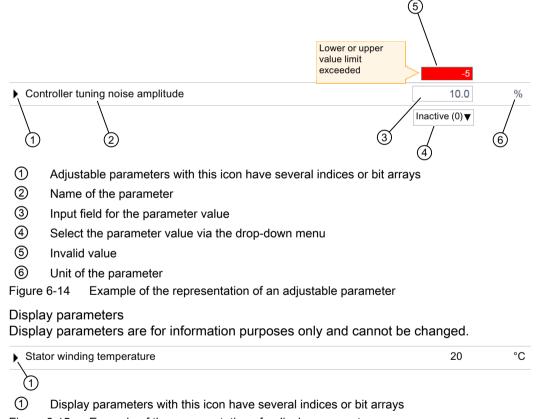
Figure 6-15 Example of the representation of a display parameter

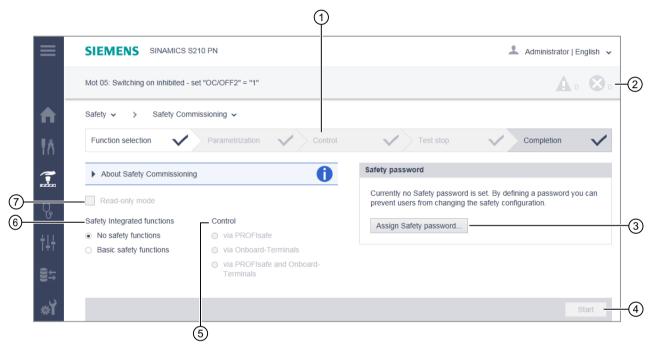
The web server provides you with a commissioning Wizard that navigates you through all of the steps required when commissioning safety. The basic handling is shown in the following diagram:

- ① Wizard with commissioning steps
- 2 Access to fault and alarm messages
- ③ Safety password
- (4) Start and carry out Safety commissioning
- Selection for controlling the safety functions
- 6 Selects the safety functions
- Activation of the read-only mode (prevents inadvertent changes)
- Figure 6-19 Overview: Safety commissioning Wizard

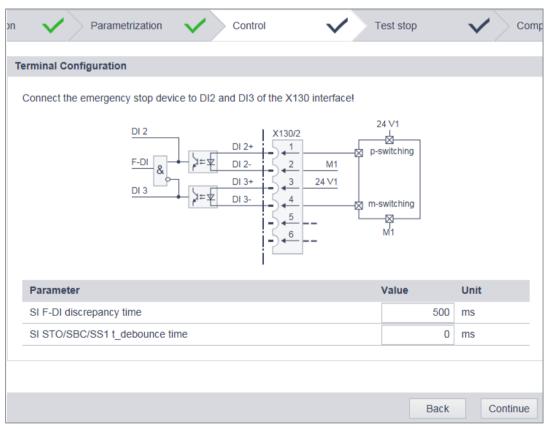
The signal states at the two terminals of an F-DI are monitored in order to determine whether these have assumed the same logical state within the discrepancy time (unavoidable time delay). The selection and deselection must be performed in both monitoring channels within this discrepancy time.

The discrepancy time and the debounce time are pre-assigned default values and do not have to be changed in most cases. See the following figure.

Figure 6-24 Parameterizing the controller via terminals

- 1. If you want to change the discrepancy time, click the "SI F-DI discrepancy time" field. An input dialog with the same name opens. Adjust the set discrepancy time and confirm with "OK".
- 2. If you want to change the debounce time, click the "SI STO/SS1 debounce time" field. An input dialog with the same name opens. Set the debounce time and confirm with "OK".
- Click "Continue". The "Test stop" commissioning step is activated.

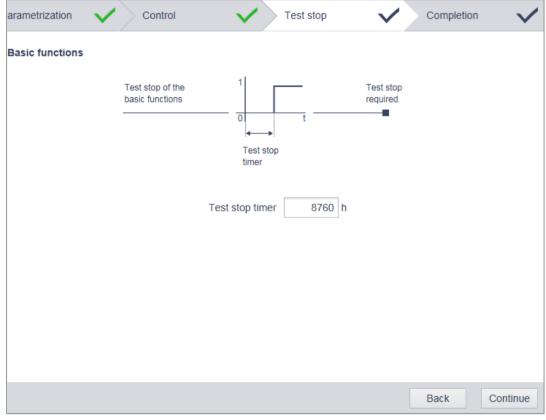
If a different time interval is required for the test stop (e.g. as the result of a risk analysis), change the interval as described in the following.

Figure 6-25 Configuring test stop (forced checking procedure)

To change the time interval, click in the "Test stop timer" field. An input dialog with the same name opens. Set the timer interval here and confirm by clicking "OK".

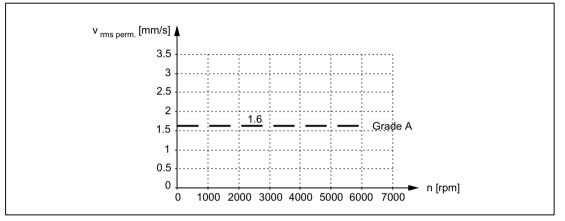
The vibration severity grade is maintained up to the rated speed (n_N) .

Figure 8-1 Vibration severity levels

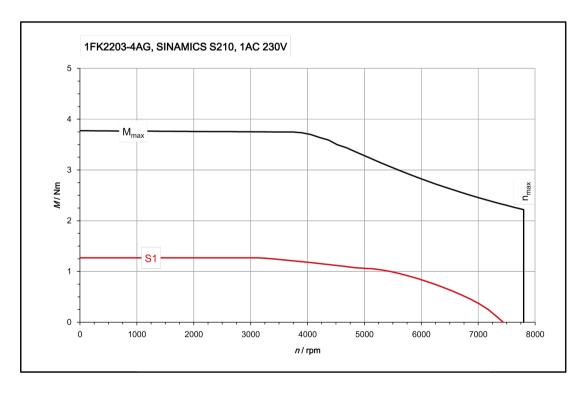
8.1.14.2 1FK2203-4AG

Technical data (in SINAMICS S210 system)	Symbol	Unit	Value
Static torque	Mo	Nm	1.27
Stall current	I ₀	A	2.52
Maximum permissible speed	n _{max}	rpm	7800
Maximum torque	M _{max}	Nm	3.75
Maximum current	I _{max}	A	7.8
Thermal time constant	T _{th}	rpm	28
Rotor moment of inertia	J _{mot}	kgcm ²	0.35
Rotor moment of inertia (with brake)	J _{mot br}	kgcm ²	0.37
Weight	m _{mot}	kg	1.57
Weight (with brake)	m _{mot br}	kg	2.1
Rated data for S210 on 230 V 1 AC	•	1	
Rated speed	n _{rated}	rpm	3000
Rated torque	M _{rated}	Nm	1.27
Rated current	I _{rated}	A	2.52
Rated power	P _{rated}	kW	0.4

The rated data applies when the converter is connected to 230 V 1 AC.

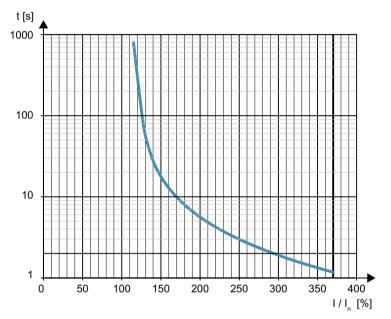
When the load exceeds the rated current, the thermal protection of the converter starts and switches the motor off in accordance with the overload characteristics shown below.

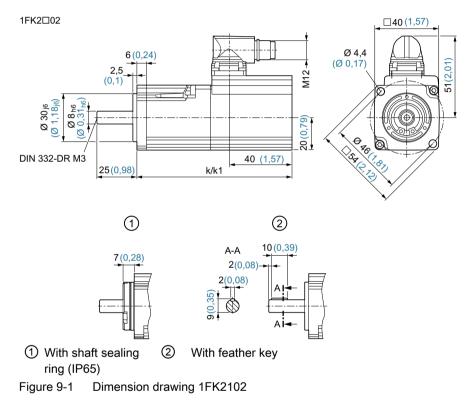
Dimension drawing 1FK2, shaft height 20

All dimensions in mm (inches).

SIMOTICS S-1FK2 shaft height 20		Dimensions		
		Without brake	With brake	
	DIN	k	k1	
	IEC	LB	LB1	
1FK2102-0A□ (50 W)		97 (3.82)	128 (5.04)	
1FK2102-1A□ (100 W)		113 (4.45)	144 (5.67)

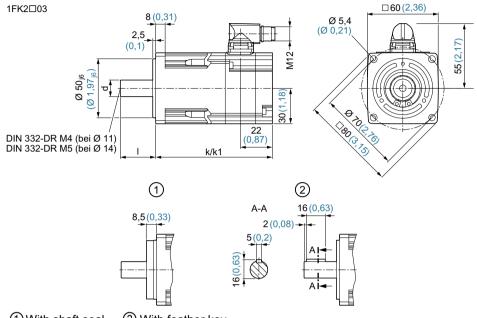
Figure 9-2 Dimension drawing 1FK2D03

Dimension drawing 1FK2, shaft height 30

All dimensions in mm (inches).

With shaft seal-With feather key ing ring (IP65)

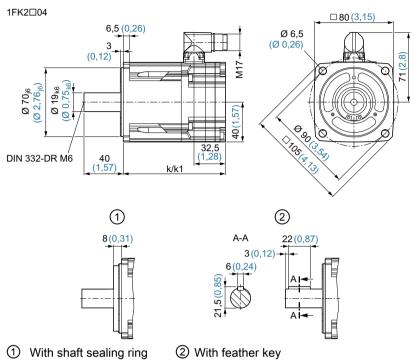
Figure 9-3 Dimension drawing 1FK2D04

Dimension drawing 1FK2, shaft height 40

All dimensions in mm (inches).

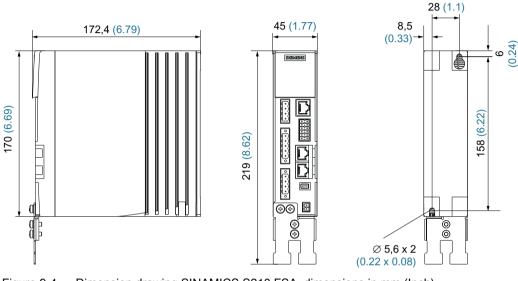
Figure 9-4 Dimension drawing SINAMICS S210 FSA, dimensions in mm (Inch)

SINAMICS S210 FSA

6SL3210-5HB10-1UF0 (100 W) 6SL3210-5HB10-2UF0 (200 W)

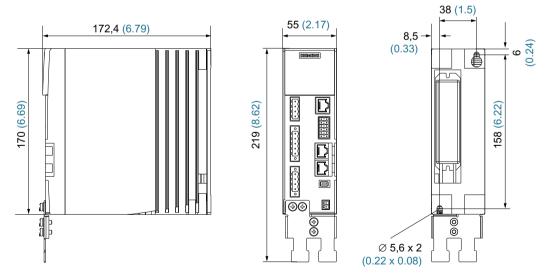
Figure 9-5 Dimension drawing SINAMICS S210 FSB, dimensions in mm (inches)

SINAMICS S210 FSB

6SL3210-5HB10-4UF0 (400 W)

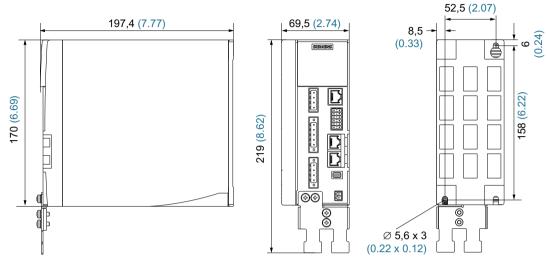
Figure 9-6 Dimension drawing SINAMICS S210 FSC, dimensions in mm (inches)

SINAMICS S210 FSC

6SL3210-5HB10-8UF0 (750 W)

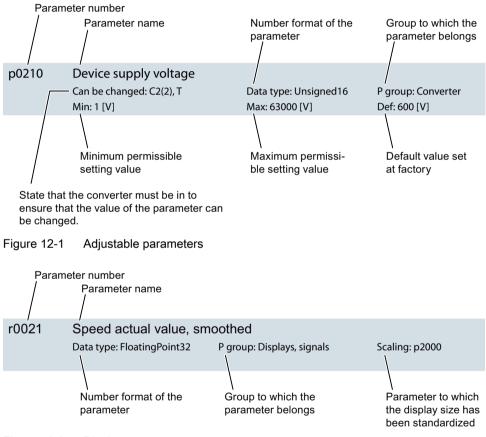
Figure 12-2 Display parameters

Some variables and settings of the converter are displayed via parameters. There are adjustable parameters and display parameters.
